LAKE CAREY DAM

NDI ID No. PA-00887 DER ID No. 66-06

PHASE I INSPECTION REPORT.

NATIONAL DAM INSPECTION PROGRAM 9-C-4015

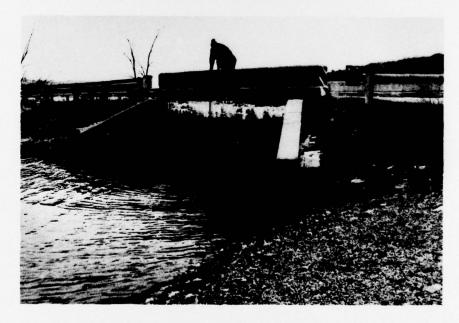
B. Bridge Between Upper and Lower Pond - Looking Upstream.

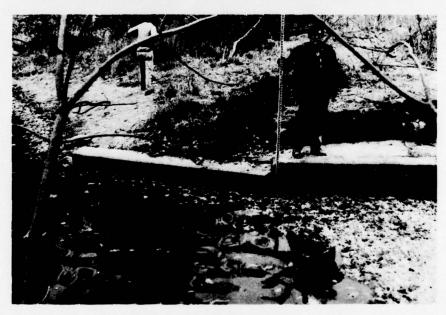
- (1) Spillway. The spillway appeared to be in fair condition. The left approach wall is tilted and offset by 0.5 foot from the spillway walls (Photograph D). The mortar is missing or deteriorated in the stone masonry spillway walls. The right wall has a shrinkage crack. There is a gouge in the embankment near the left spillway wall (Photograph E). Stoplog slots were constructed in the spillway walls. The Owner reports that the stoplogs are no longer in use.

- approach wall has evidence of relative movement, probably caused by ice pressure or frost heave. The shrinkage crack in the right wall is probably caused by improper joint locations. The deteriorated mortar prevents the spillway walls from acting as a watertight structure and can only increase the seepage potential. The gouge to the left of the spillway is probably caused by a stone from the masonry wall being removed. The conditions at the outlet works are of concern. In view of the uncertain plugging procedures for the old conduit a potential for collapsing of the conduit and settlement of the embankment might be present.

D. Spillway Left Approach Wall.

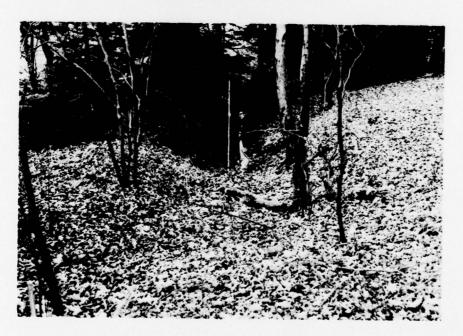
F. Auxiliary Spillway Channel.

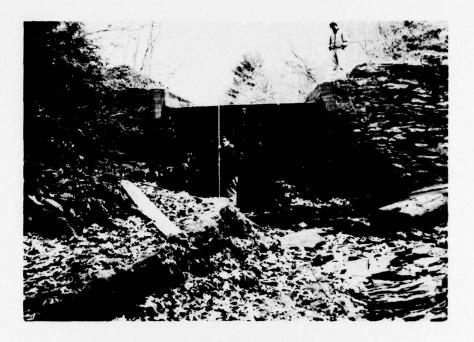
G. Downstream Face of Dam.

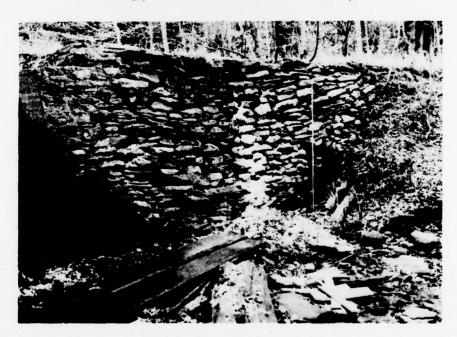
H. Downstream Face of Dam to Left of Spillway.
